## Inspection Report

**Property Address:**  
123 Elm Street  
Anytown TN 37075

**All-Pro Home Inspections LLC**

<b>Date:</b> 5/29/2013	<b>Time:</b> 08:57 AM	<b>Report ID:</b>
<b>Property:</b> 123 Elm Street Anytown TN 37075	<b>Customer:</b> John Anyone

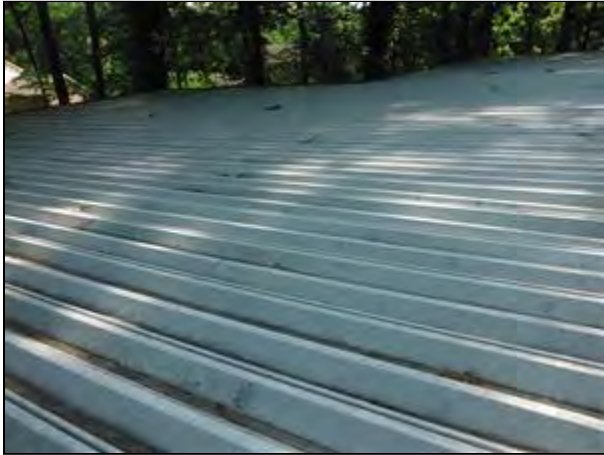
1.0 Item 1(Picture) Carport Roof

1.0 The roofing systems appears to be new to the home and working properly at the time of the inspection.

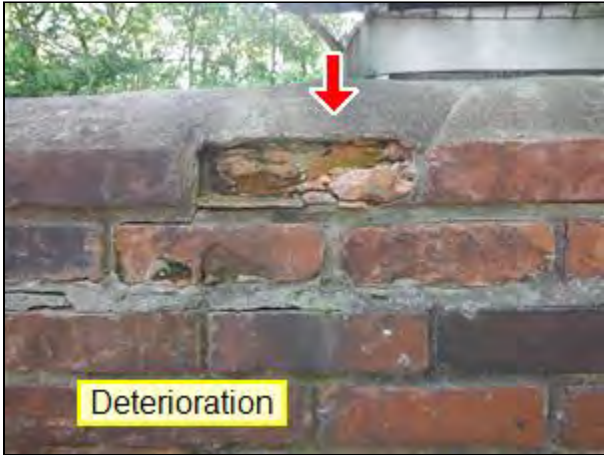
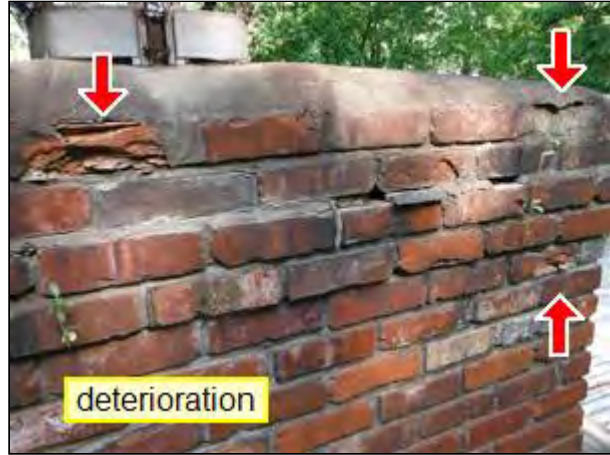
1.2 Item 1(Picture) Chimney Chase

🏠 1.2 There are some bricks in the chimney chase that are showing signs of deterioration. These areas will eventually need to be repaired/replaced.

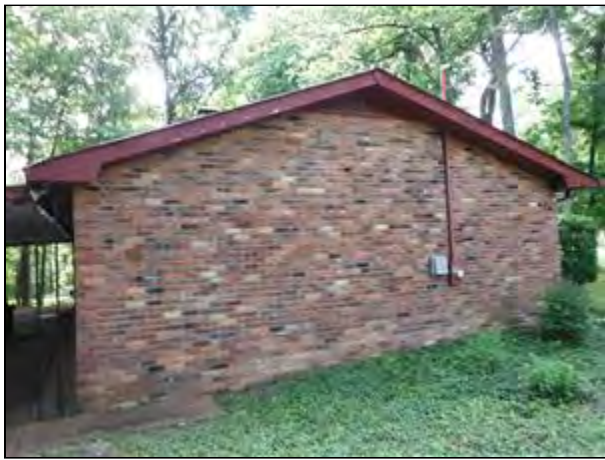
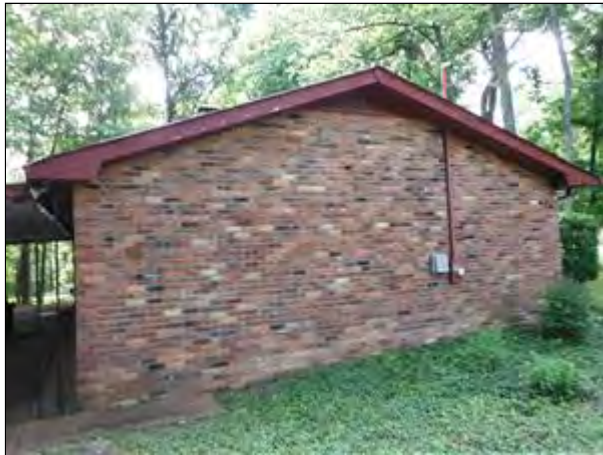
2.0 Item 1(Picture) Left side of home

📍 2.0 There are two cracks in the brick exterior on the home, front right corner and back left corner, that appear to be structural in nature. I recommend having a structural contractor/engineer to evaluate for repair options.

The home has several small step cracks in the exterior, these appear to be normal settling. Watch for any further development. Seal to help prevent moisture from entering.

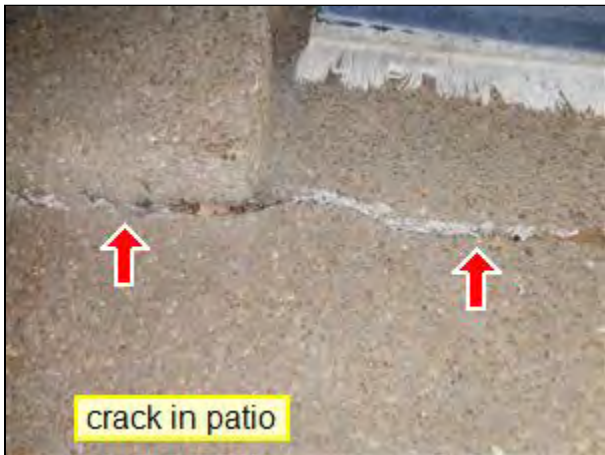
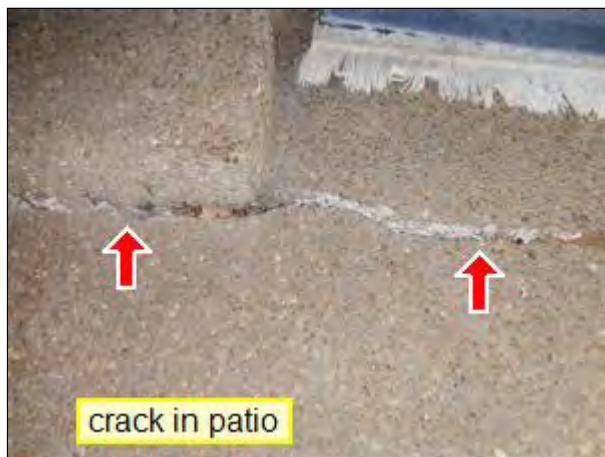
2.3 Item 1(Picture) Patio

🏠 2.3 The patio has some cracks that need to be repaired to prevent any further damage.

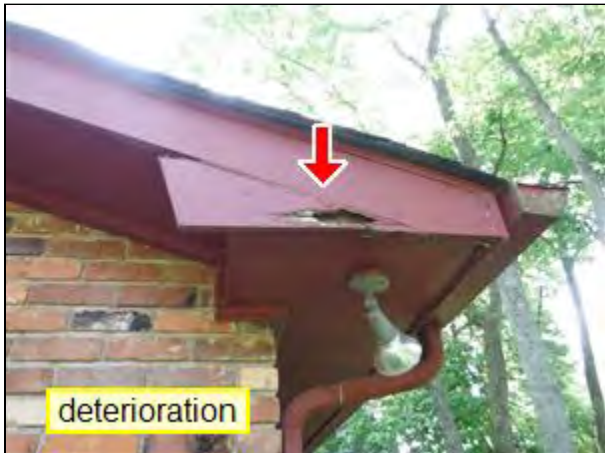
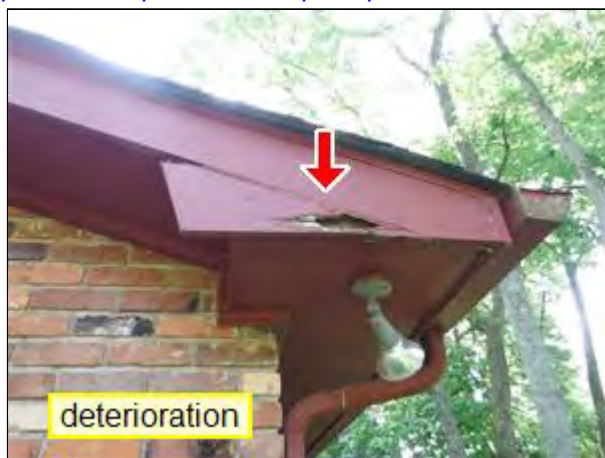
2.5 Item 1(Picture) Eave on corner

🏠 2.5 Some of the wood around the home on the eaves is starting to deteriorate. These areas need to be repaired, primed and painted to help keep the moisture out.

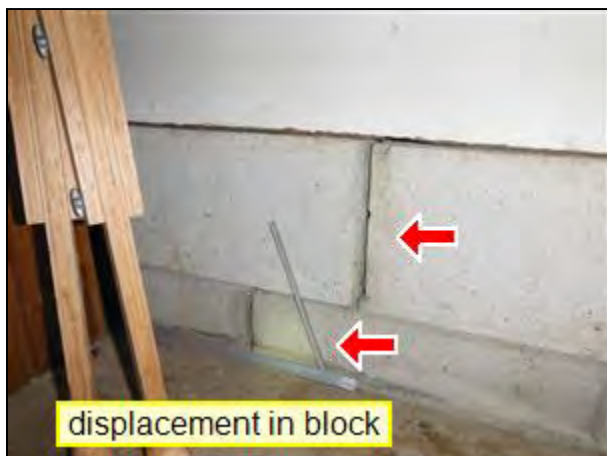
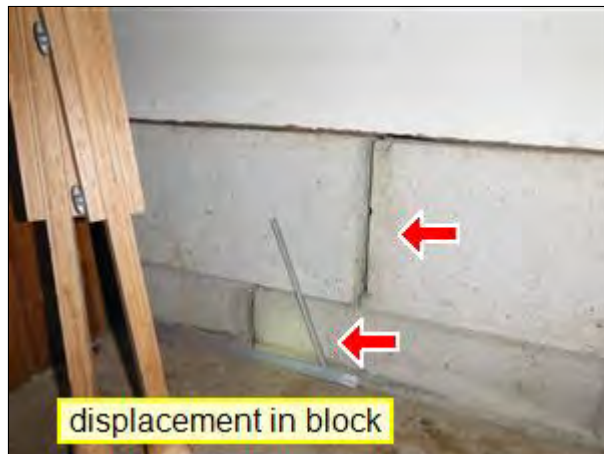
3.1 Item 1(Picture) Garage front wall

**3.1** The garage front wall is showing signs of displacement due to movement. I recommend a structural contractor/engineer to evaluate for repairs.

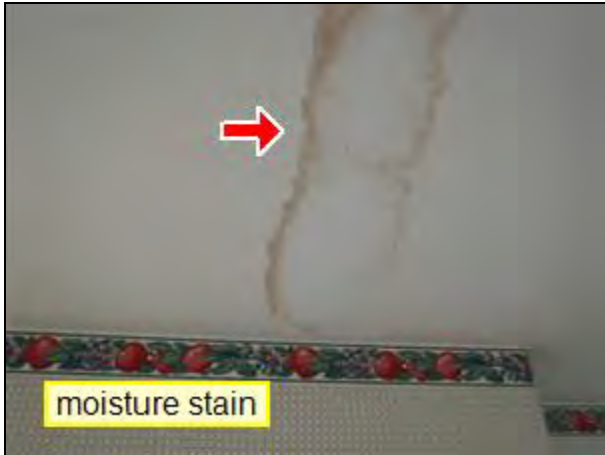
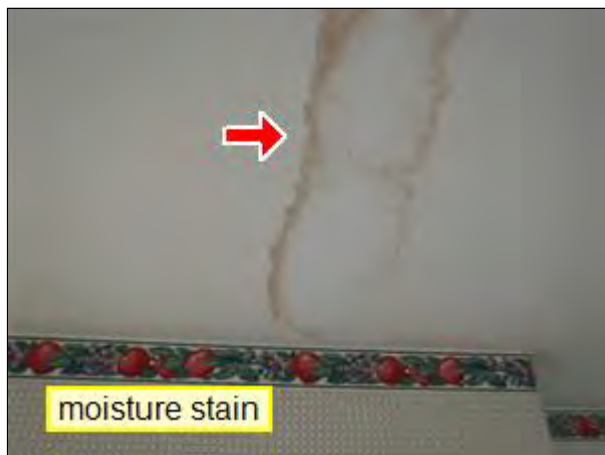
4.0 Item 1(Picture) Kitchen Ceiling

🏠 4.0 The kitchen ceiling and Den ceiling has several moisture stains from previous leaks. The areas were dry at the time of the inspection. Watch for any further developments.

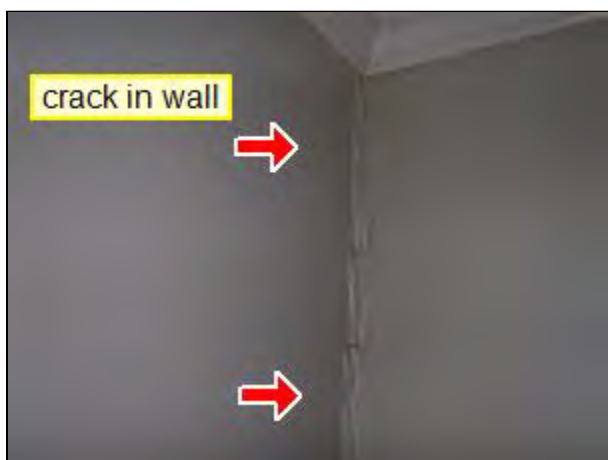
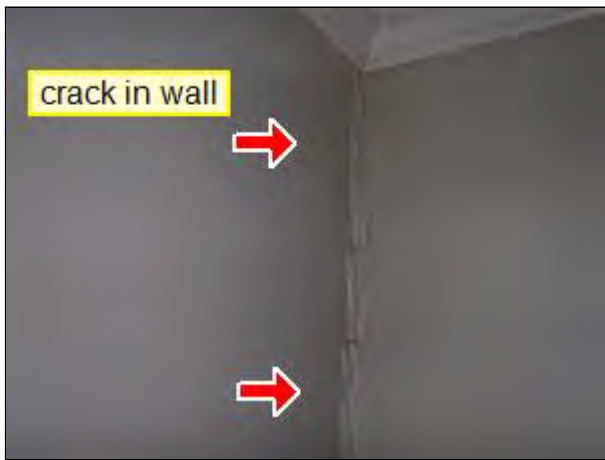
4.1 Item 3(Picture) Living room

There are some cracks in the front bedroom and living room that appear to be structural in nature. These areas will need to be evaluated by a structural contractor/engineer for repair options.

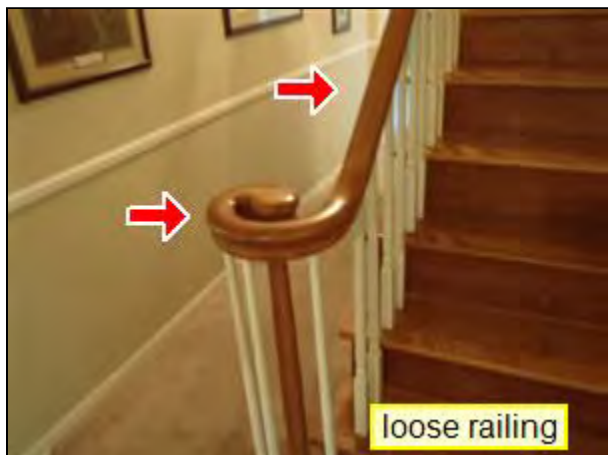
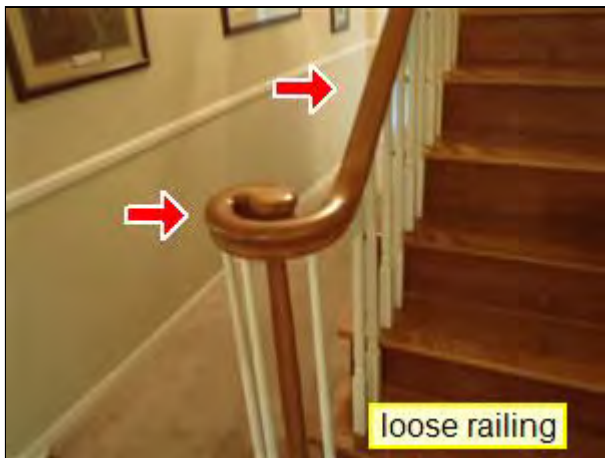
4.3 Item 1(Picture) Railing

🏠 4.3 The railing for the stairs is loose on both sides, this will need to be repaired.

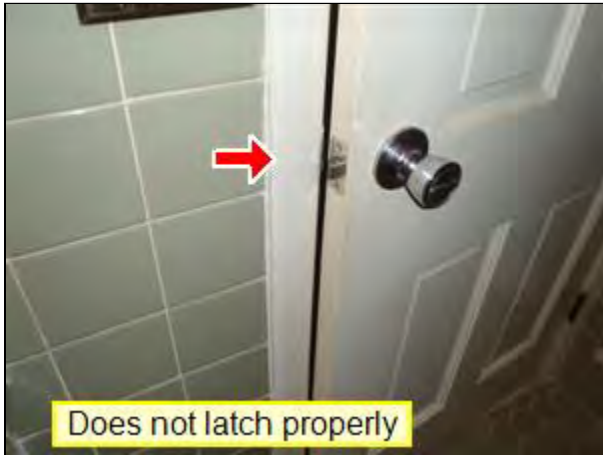
4.5 Item 1(Picture) Upstairs Bathroom Door

🏠 4.5 Several doors in the home do not latch properly, they will need to be adjusted.

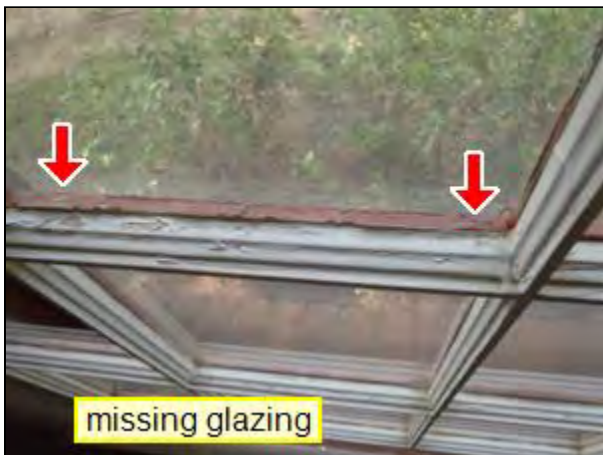
4.6 Item 1(Picture) Front right bedroom

4.6 The window in the front right bedroom has some broken/missing glazing, this will need to be repaired.

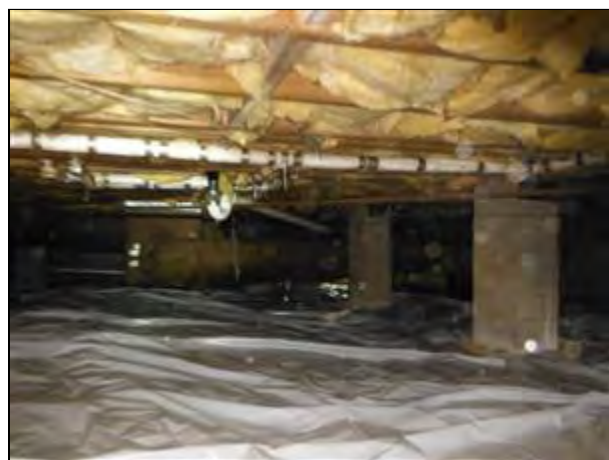
5.0 Item 1(Picture) Crawlspace

5.0 The crawlspace was dry at the time of the inspection.

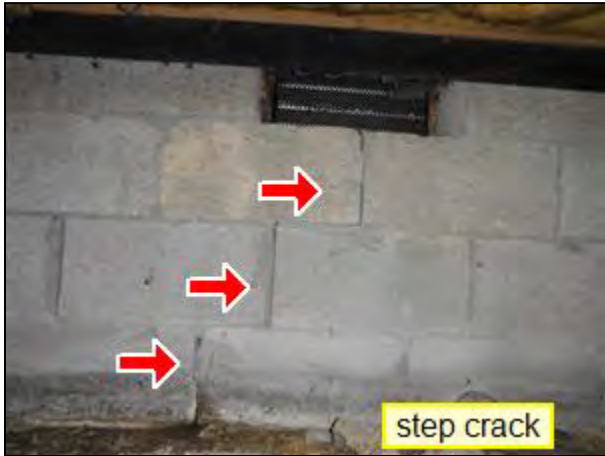
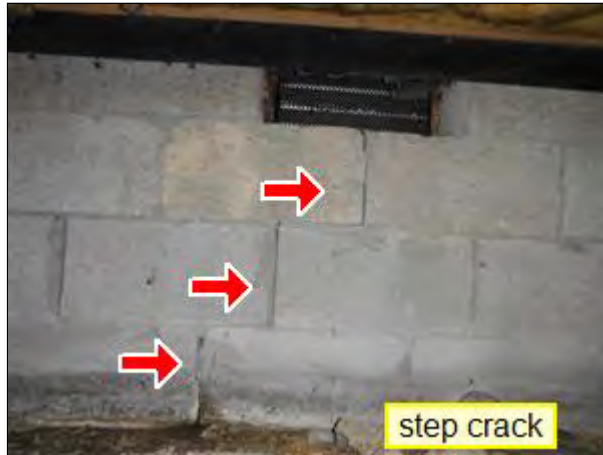
5.1 Item 1(Picture) Crawspace wall

5.1 There are several cracks in the crawspace walls that correspond with the several cracks on the exterior brick walls. These need to be evaluated by a structural contractor/engineer for repair options.

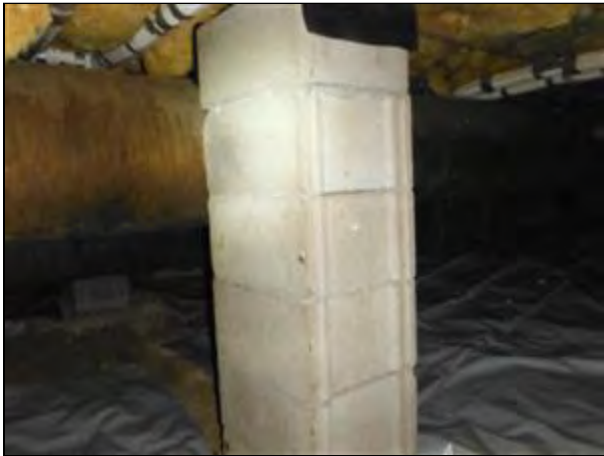
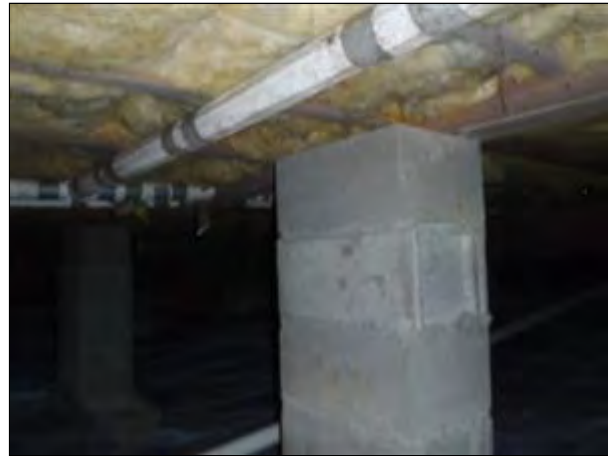
5.2 Item 1(Picture) Concrete Piers

5.2 The home uses a concrete pier system for support.

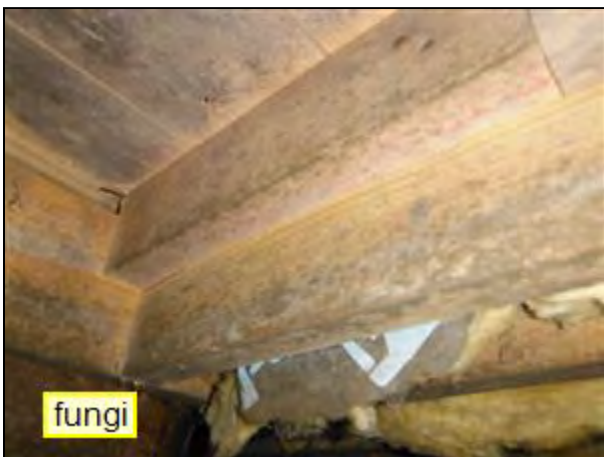
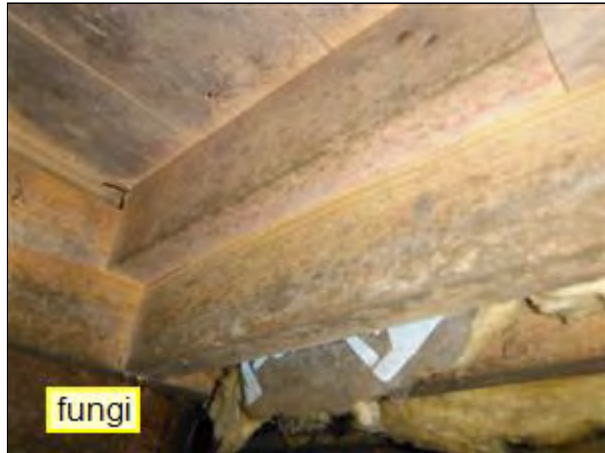
5.3 Item 1(Picture) Sub Floor

5.3 Signs of fungi growth is present on the floor system in crawlspace in several areas. We did not inspect, test or determine if this growth is or is not a health hazard. The underlying cause is moisture. I recommend you contact a mold inspector or expert for investigation or correction if needed.

There is a sub floor joist under the front bedroom area that is deteriorated and will need to be repaired/replaced.

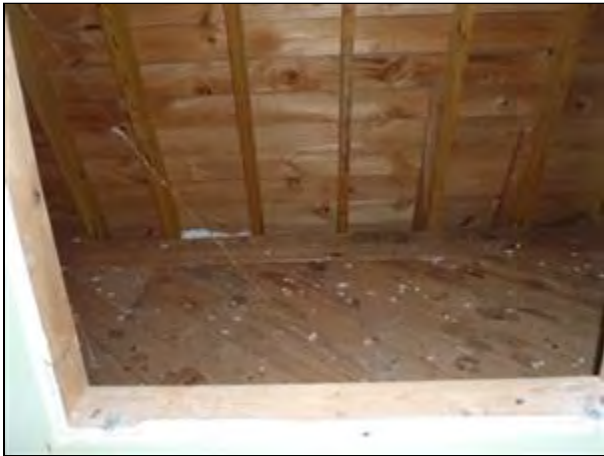
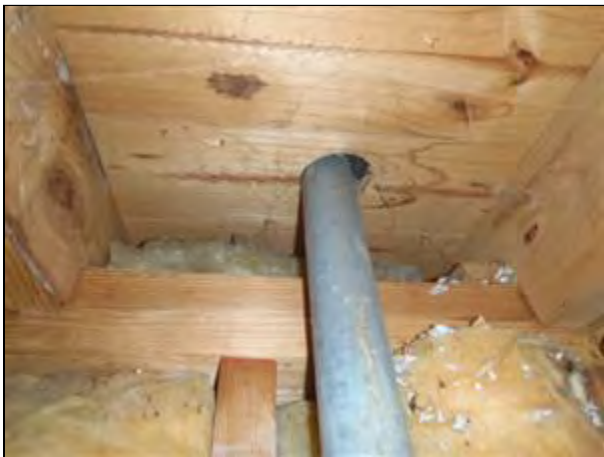
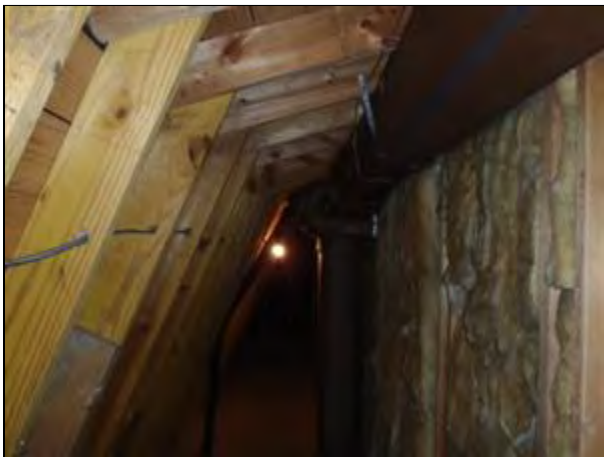
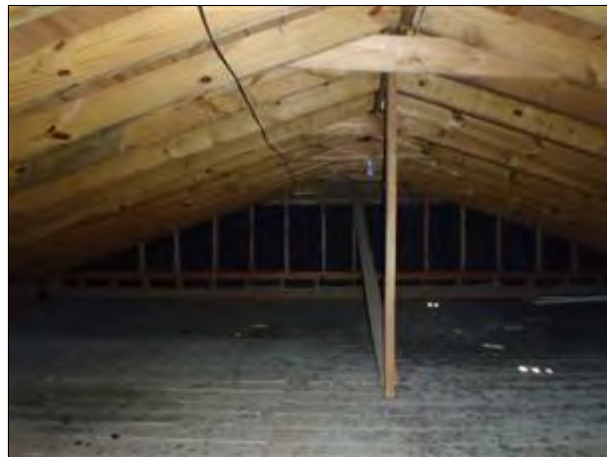
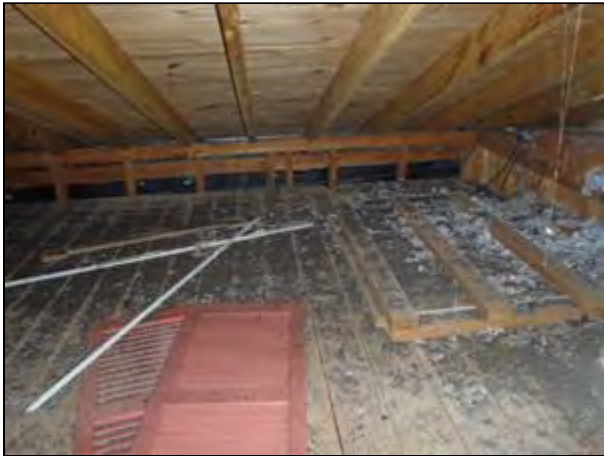
5.5 Item 1(Picture) Roof structure

🏠 5.5 There is a small gap in the roof structure, over lower level, that need to be sealed.

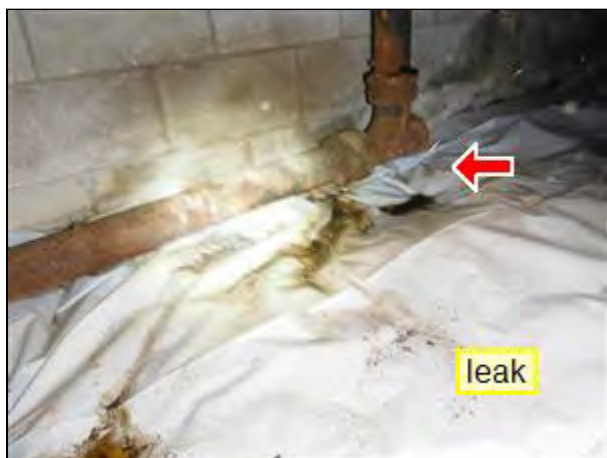
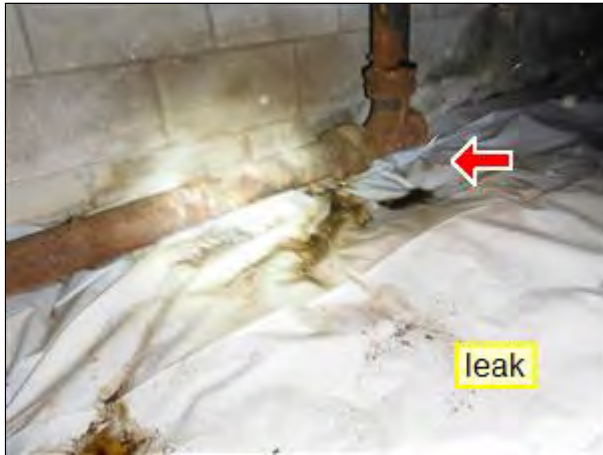
6.0 Item 1(Picture) Plumbing drain under hall toilet

**6.0** There appears to be a leak under the hall toilet in the crawlspace, this will need to be repaired.

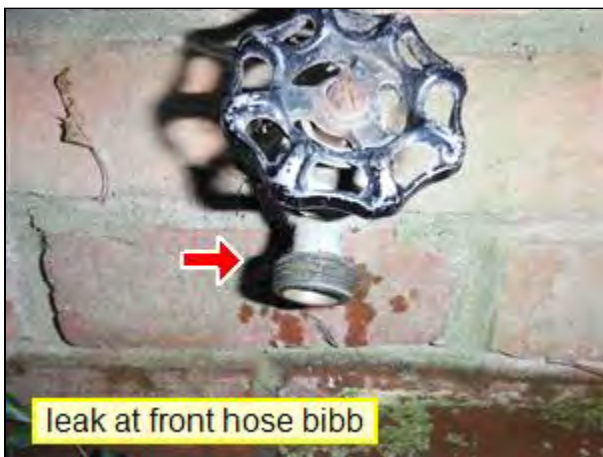
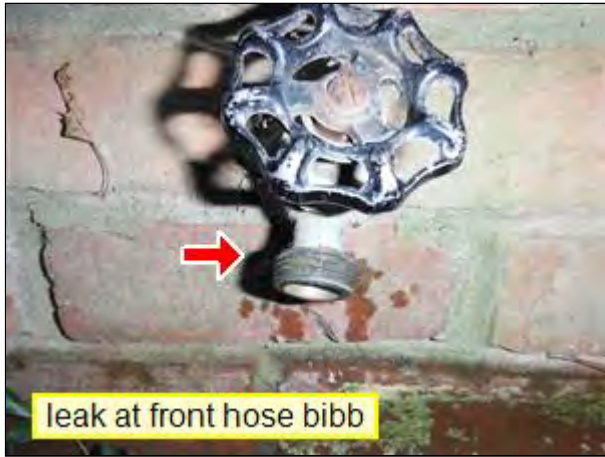
6.1 Item 1(Picture) Front of home

🏠 6.1 The front outside hose bibb on the front of the home is leaking, this will need to be repaired.

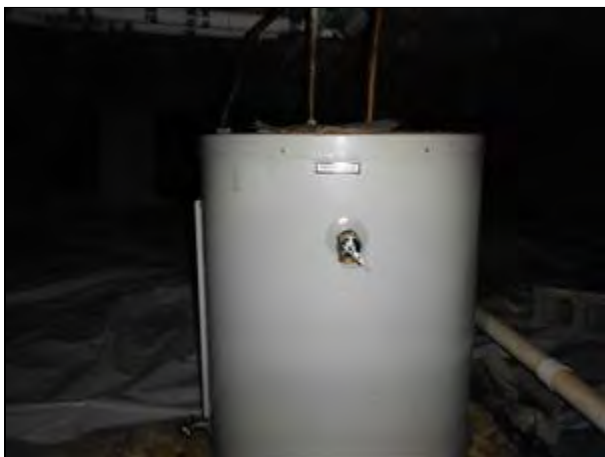
6.2 Item 1(Picture) Water Heater

6.2 The hot water heater appeared to be adequate at the time of the inspection.

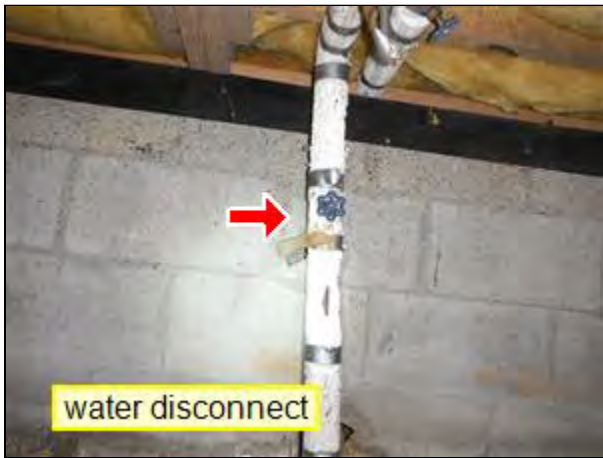
6.3 Item 1(Picture) Water shut off under home

**6.3** The main water shut off is located under the home.

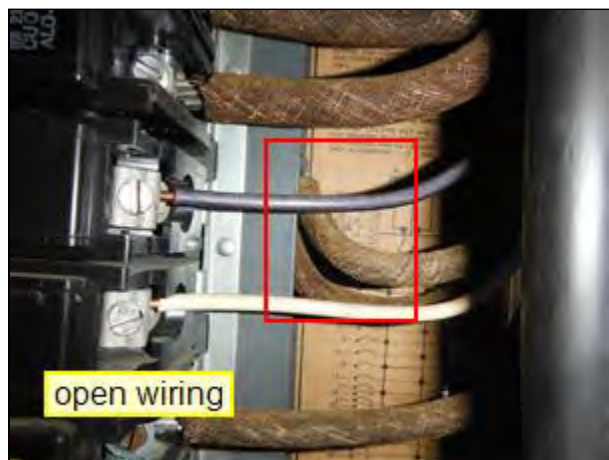
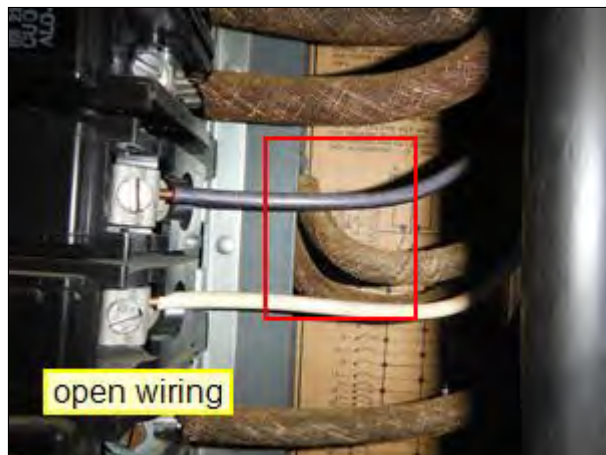
7.2 Item 1(Picture) Electrical Panel

**7.2 Problem(s) discovered with Branch Circuits such as open wiring and any other problems that an electrical contractor may discover while performing repairs need correcting. I recommend a licensed electrical contractor inspect further and correct as needed.**

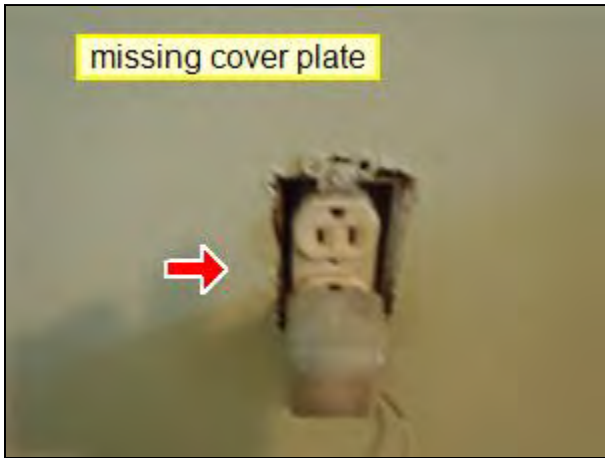
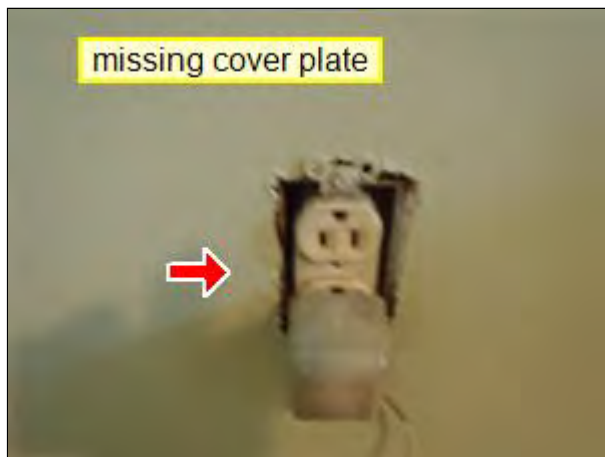
7.3 Item 1(Picture) Outlet upstairs

7.3 There is an outlet upstairs that needs a cover plate.

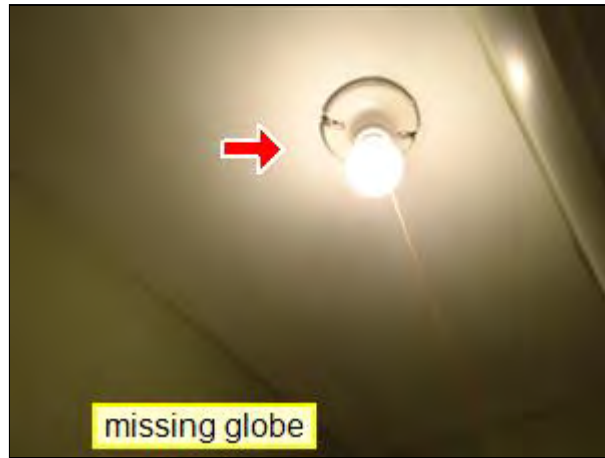
7.3 Item 2(Picture) Closet Light

There are several lights in the closets that are missing globes for safety. Replace.

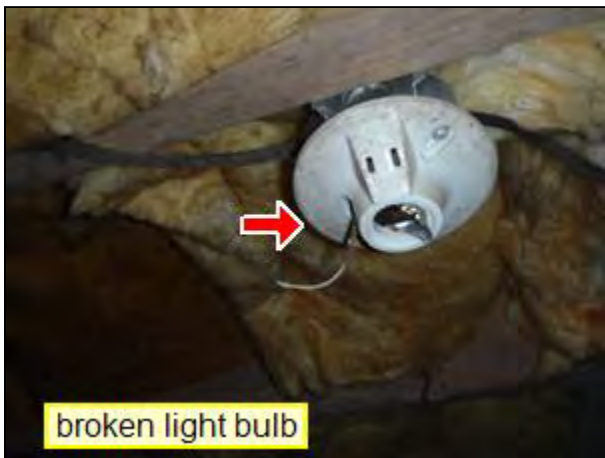
7.3 Item 3(Picture) Light in crawlspace

There is a broken light bulb in the crawlspace, repair.

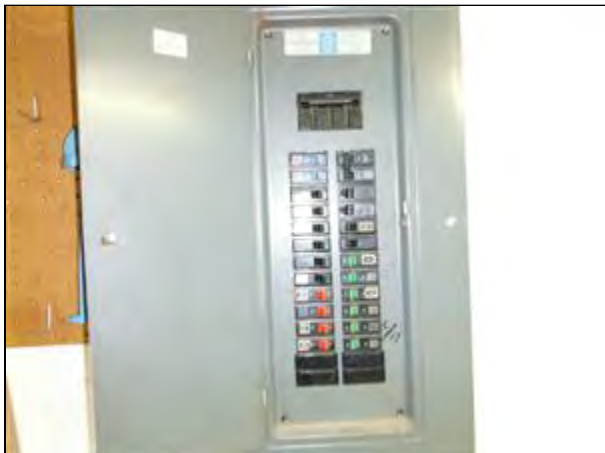
7.6 Item 1(Picture) Electrical Panel

7.6 The main panel is located in the garage. It appeared adequate at the time of the inspection.

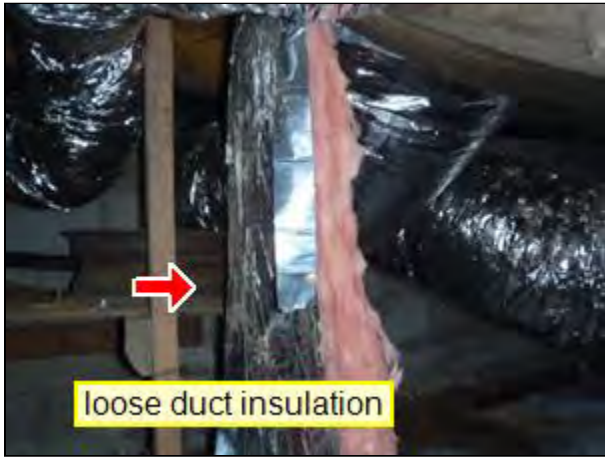
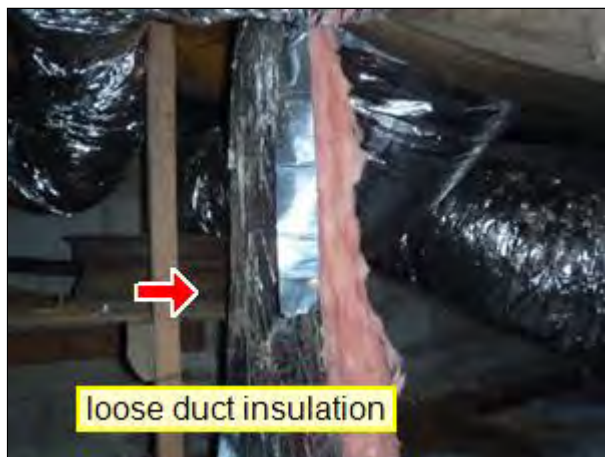
8.3 Item 1(Picture) Duct in crawlspace

8.3 There is some loose insulation off the duct work in the crawlspace. Repair.

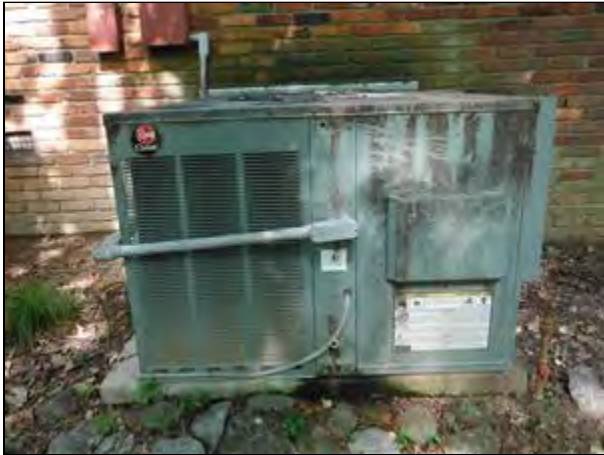
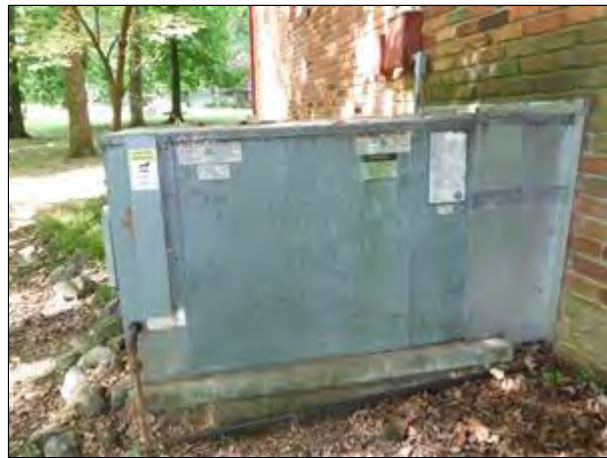
8.7 Item 1(Picture) HVAC System

The AC system was working properly at the time of the inspection

I do recommend having the unit placed on a maintenance plan for yearly service to help prolong the life of the units. I am unable to determine the remaining life of the units.

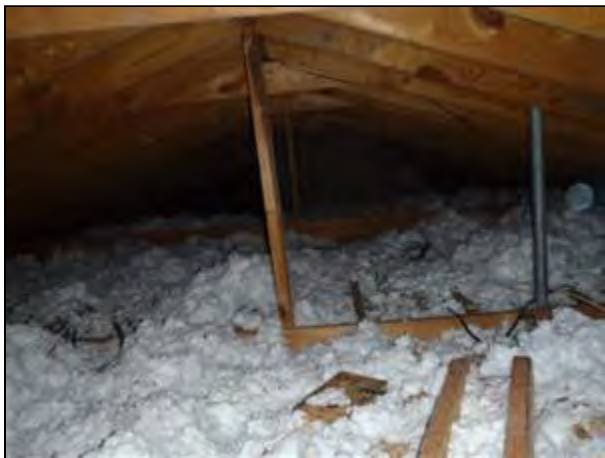
9.0 Item 1(Picture) Attic Insulation

**9.0** Insulation in attic appears to be adequate.

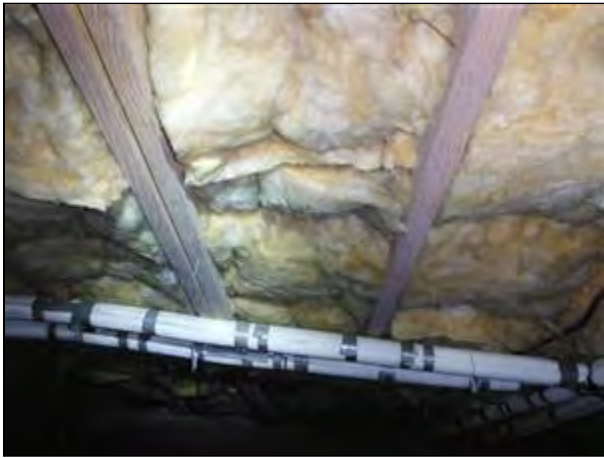
9.1 Item 1(Picture) Insulation in sub floors

9.1 The floor system is insulated.

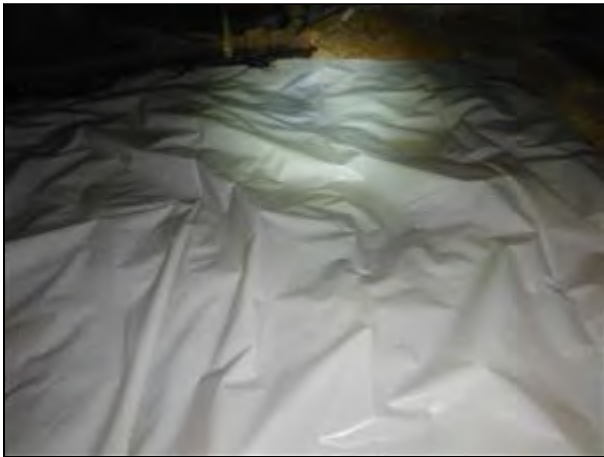
9.2 Item 1(Picture) Vapor Barrier

9.2 There is the presence of a vapor barrier (plastic on crawlspace floor) in the crawlspace.

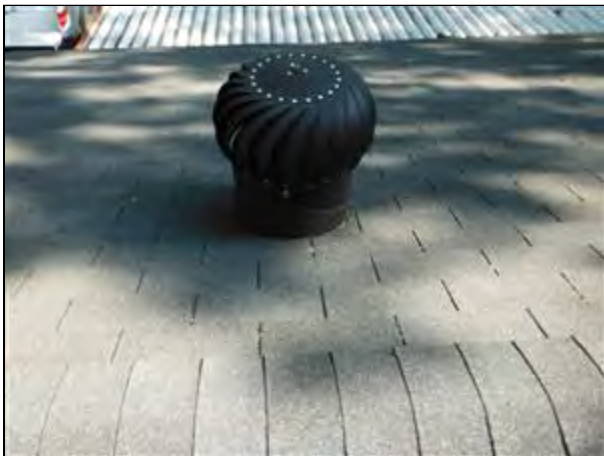
9.3 Item 1(Picture) Attic Vents

9.3 The home uses some passive vents for attic ventilation and they appear adequate at the time of the inspection.

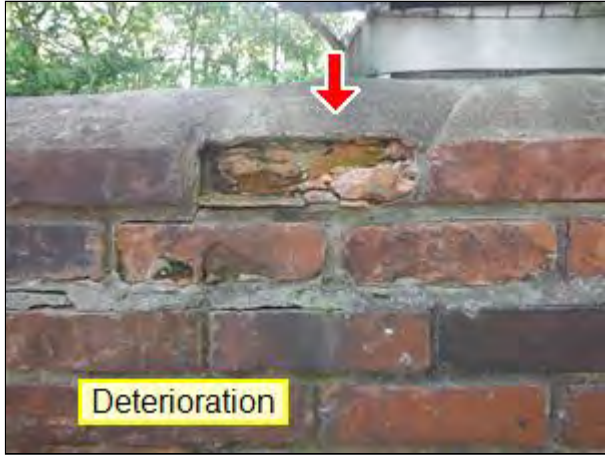
1.2 Item 1(Picture) Chimney Chase

There are some bricks in the chimney chase that are showing signs of deterioration. These areas will eventually need to be repaired/replaced.

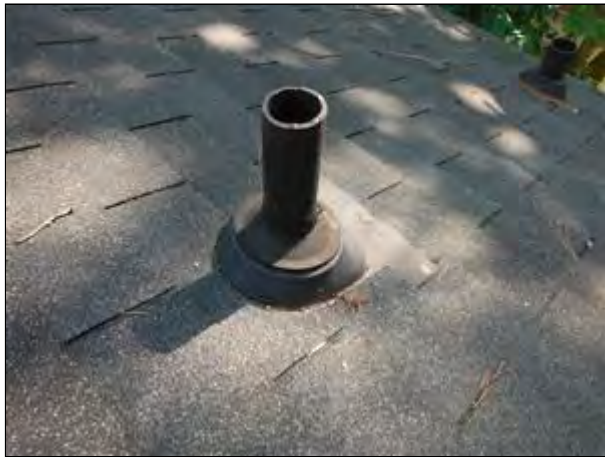
1.2 Item 3(Picture) Plumbing vent boots

The plumbing vent pipes and boots appear to be adequate at the time of the inspection

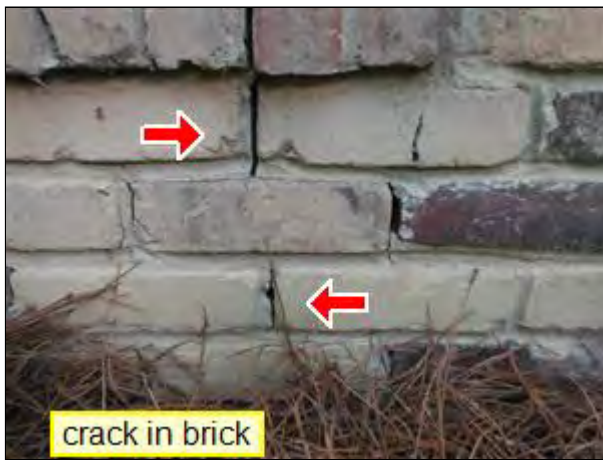
2.0 Item 3(Picture) Brick Exterior

There are two cracks in the brick exterior on the home, front right corner and back left corner, that appear to be structural in nature. I recommend having a structural contractor/engineer to evaluate for repair options.

The home has several small step cracks in the exterior, these appear to be normal settling. Watch for any further development. Seal to help prevent moisture from entering.

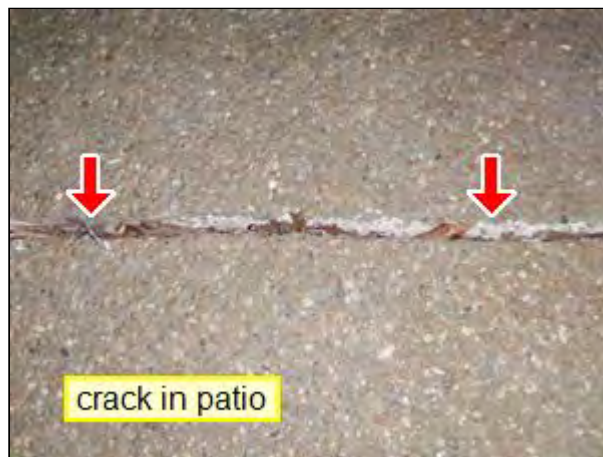
2.3 Item 2(Picture) Patio

The patio has some cracks that need to be repaired to prevent any further damage.

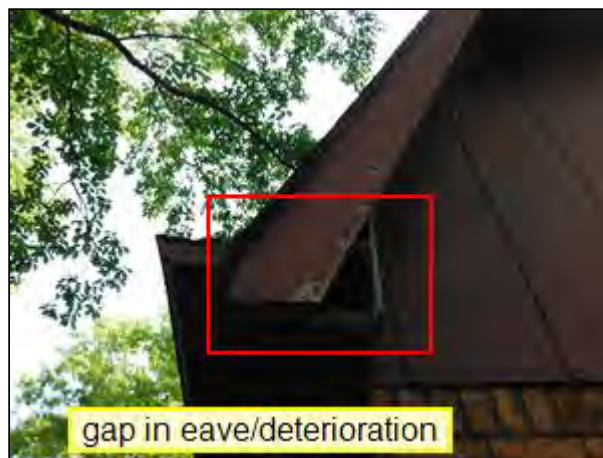
2.5 Item 2(Picture) front of home

Some of the wood around the home on the eaves is starting to deteriorate. These areas need to be repaired, primed and painted to help keep the moisture out.

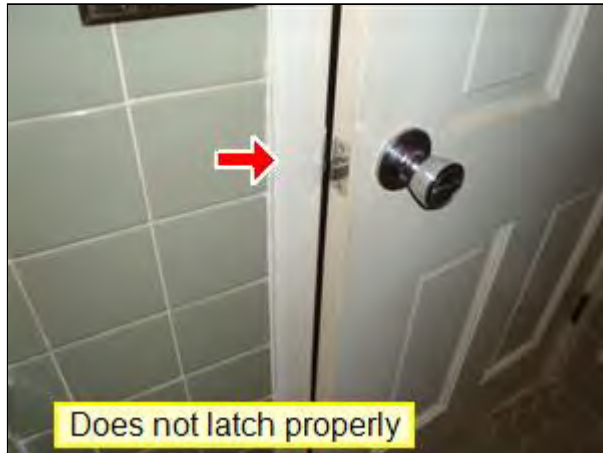
4.5 Item 1(Picture) Upstairs Bathroom Door

Several doors in the home do not latch properly, they will need to be adjusted.

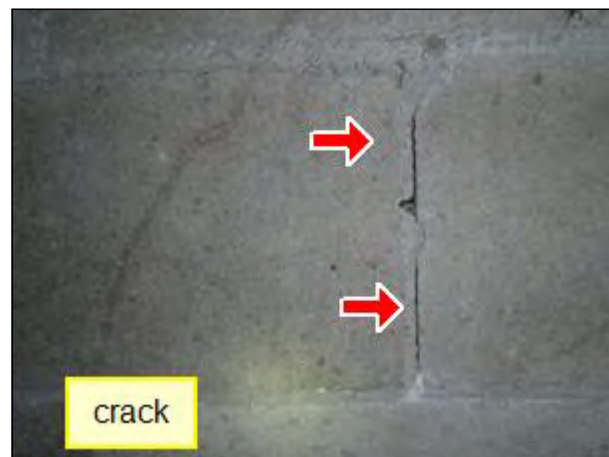
5.1 Item 4(Picture) Crawspace wall

There are several cracks in the crawlspace walls that correspond with the several cracks on the exterior brick walls. These need to be evaluated by a structural contractor/engineer for repair options.

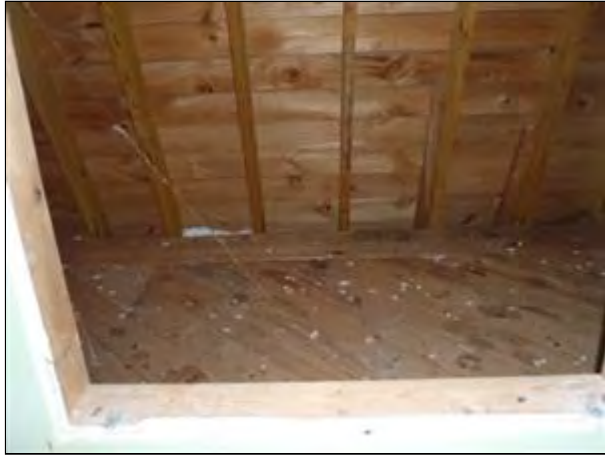
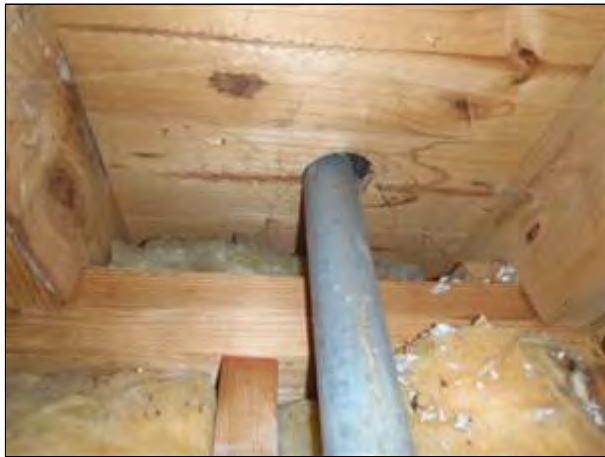
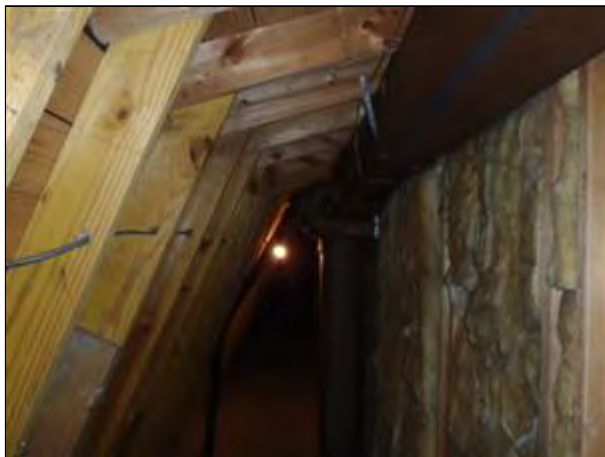
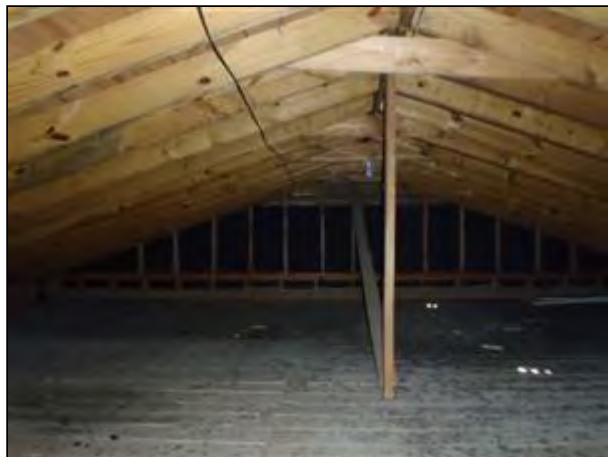
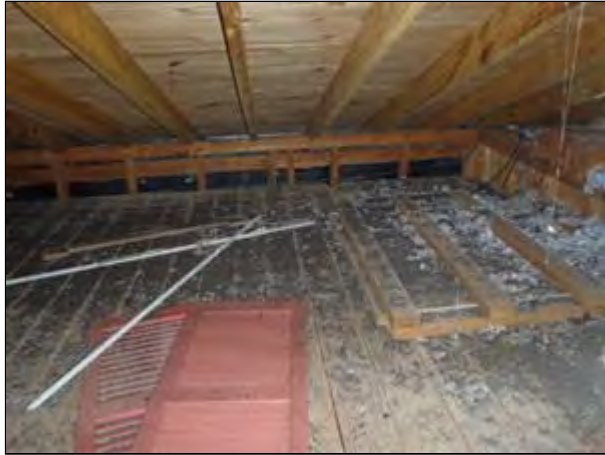
There is a small gap in the roof structure, over lower level, that need to be sealed.

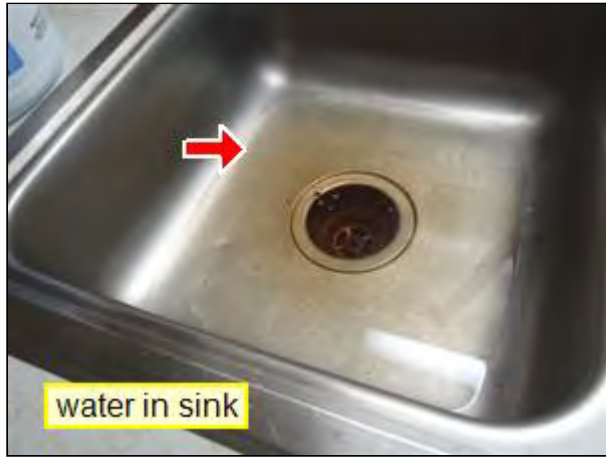
6.1 Item 2(Picture) Kitchen sink

The kitchen sink appears to be not draining properly, this will need to be repaired.

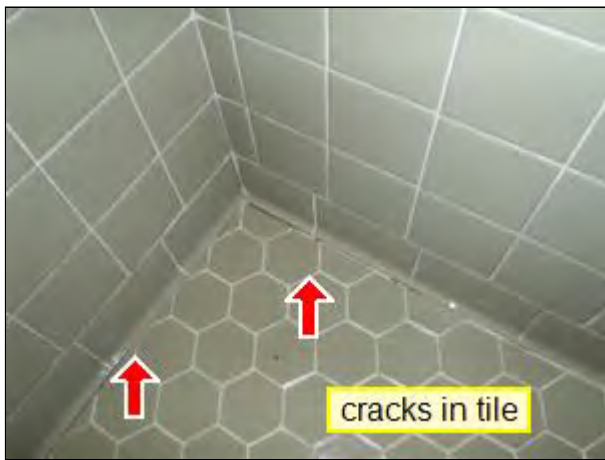
6.1 Item 3(Picture) Upstairs Shower Floor

The upstairs shower floor has cracks/gaps in the tile. These areas will need to be repaired to prevent water leaks.

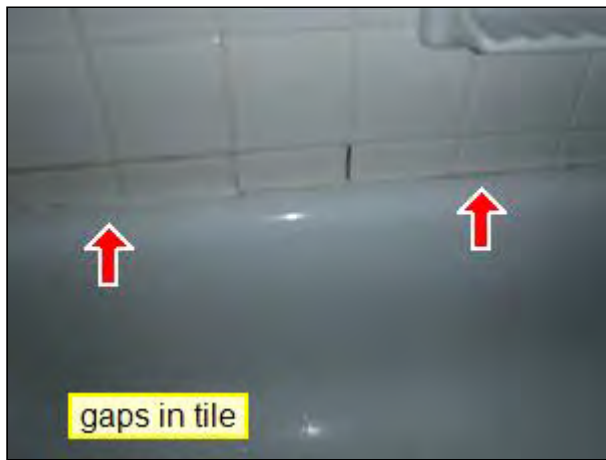
6.1 Item 4(Picture) Downstairs Tub

The downstairs bathtub has cracks/gaps in the tile. These areas will need to be repaired to prevent water leaks.

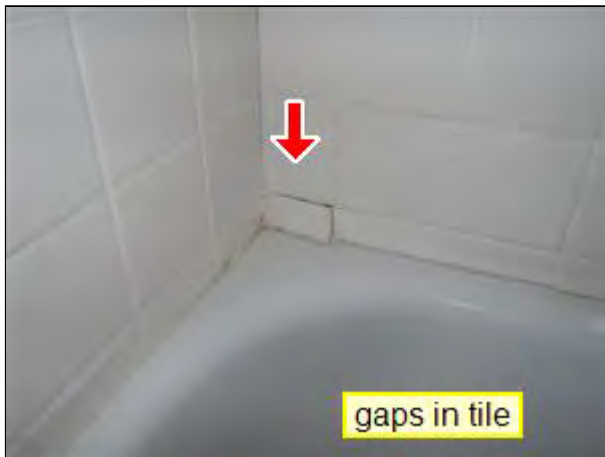
6.1 Item 5(Picture) Downstairs Tub

The downstairs bathtub has cracks/gaps in the tile. These areas will need to be repaired to prevent water leaks.

The tub downstairs is missing a handle and there is a chip in the bottom, repair/replace.

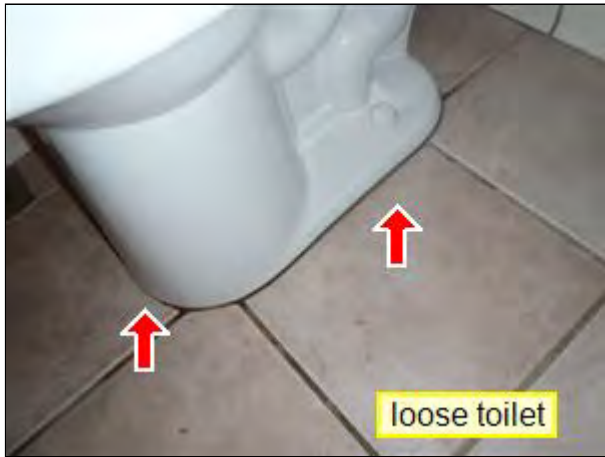
6.1 Item 9(Picture) Downstairs Bathroom

The toilet is loose in the downstairs bathroom, secure.

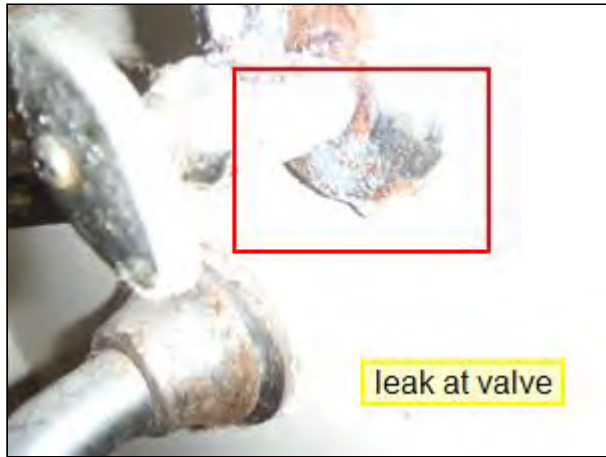
6.1 Item 10(Picture) Laundry room sink

There is a leak at the cold water supply line at the laundry room sink, repair.

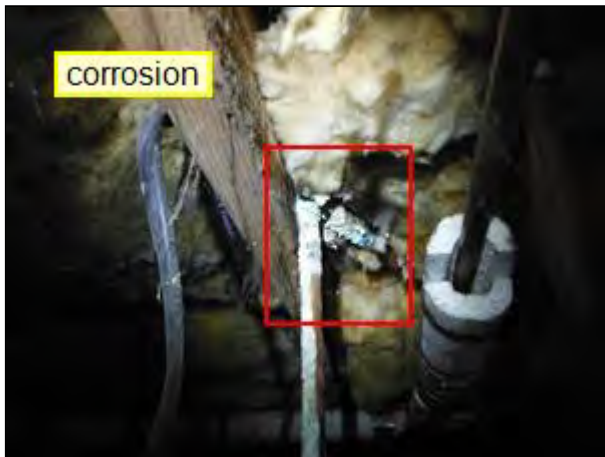
6.1 Item 11(Picture) Water Line above water heater

There is a water line in the crawlspace above the water heater that is showing signs of corrosion. This will need to be repaired.

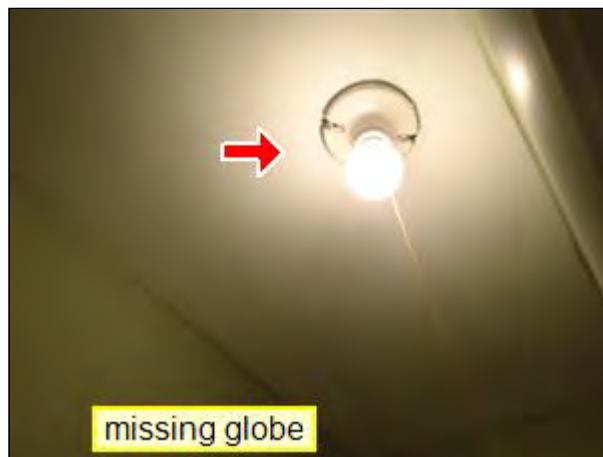
7.3 Item 2(Picture) Closet Light

There are several lights in the closets that are missing globes for safety. Replace.
